TECHNICAL REPORT ARCCB-TR-02016

CHARACTERIZATION OF EXPLOSIVELY BONDED AND FIRED TANTALUM LINERS APPLIED TO 25-MM GUN TUBES

NOVEMBER 2002

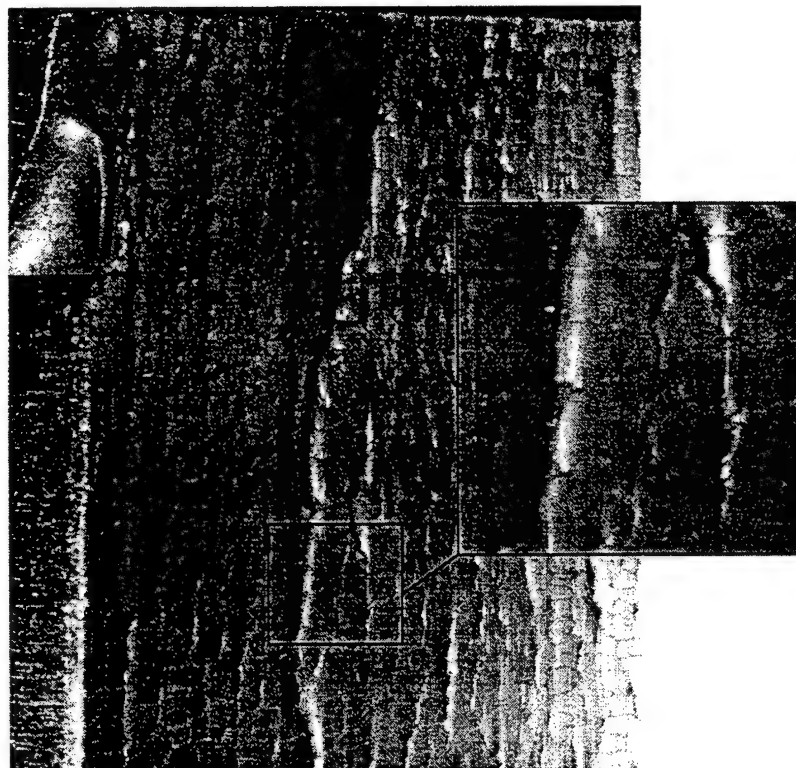
The most predominant erosion patterns of Tube B were readily distinguishable with visual and stereomicroscopic examination. Heavy heat-checking and thermomechanical/thermochemical damage of the coating is evident at the 6- to 10-inch location, along with the development of deep erosion troughs that extend well into the steel (Figures 3 and 4).

Figure 3. Severe heat-checking and gas erosion exhibited at the 6.5-inch location of Tube B.

Following sufficient uniform erosion of the liner, the propensity for blow-by of the hot gases due to poor obturation increases. This stage of the erosion process is illustrated by the gas-wash grooves shown in Figures 3 and 4. The inset in Figure 3 is an example of a gas-wash groove following along the heat-check cracking caused by hydrogen embrittlement. The heat-check cracks act as a conduit for the axially oriented gas-wash grooves, thus increasing the speed of this erosion process. Figure 44 is a cross-section taken at the 10-inch from RFT location, and illustrates the severity and dominance of the hot gas erosion at this stage. The final stage of the erosion process exhibited in this tube is in full erosion of the liner at an axially oriented groove and subsequent rapid erosion in the steel as is illustrated in Figure 45.

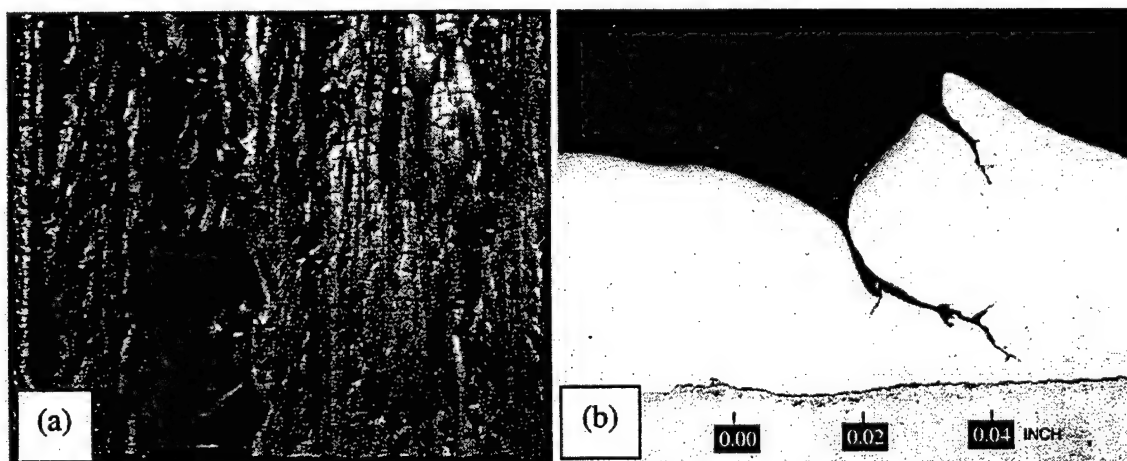
Figure 4. (a) Severe heat-checking and gas erosion exhibited at 8 inches from the rear face of the tube (RFT), and (b) cross-section of Tube B at 50X.

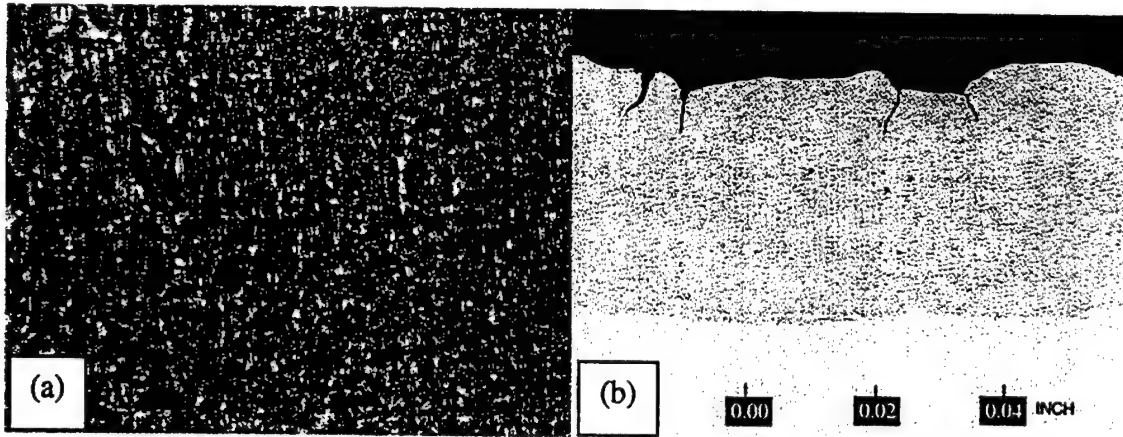
Heat-checking was also evident at the 12- to 14-inch location, along with a general surface roughening as shown in Figure 5a. This roughening is due to the cracking followed by some plastic flow and erosion in this area. This was confirmed by metallographic observations made at this location (Figure 5b).

Figure 5. (a) Surface roughening exhibited at 12 to 14 inches from RFT, and (b) cross-section of Tube B at 50X.

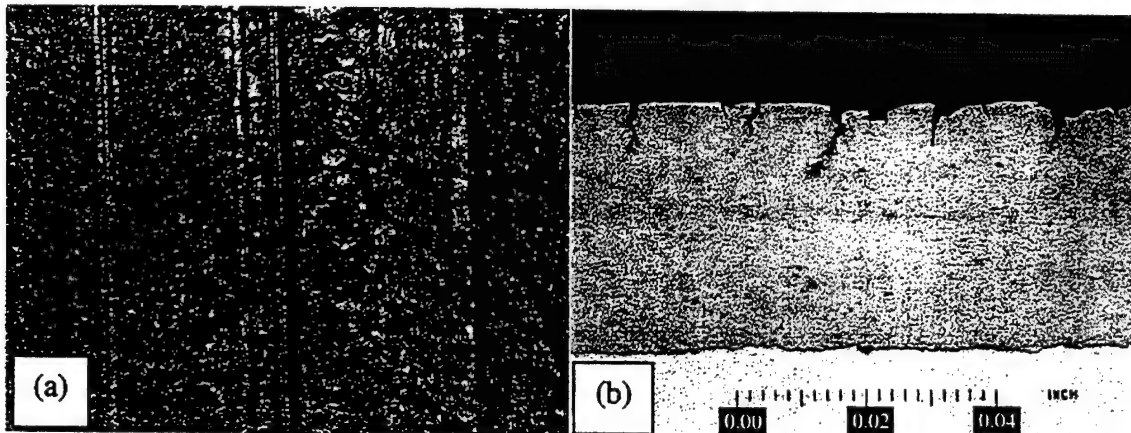
Acute surface roughening was seen in the 18- to 20-inch location (Figure 6). Upon metallographic examination, it was found that cracking also contributed to roughness at this location. Here, the cracks are more finely spaced and shallower than in the locations closer to the breech.

Figure 6. (a) General surface roughening seen at 18 to 20 inches from RFT, and (b) longitudinal cross-section of Tube B at 50X.

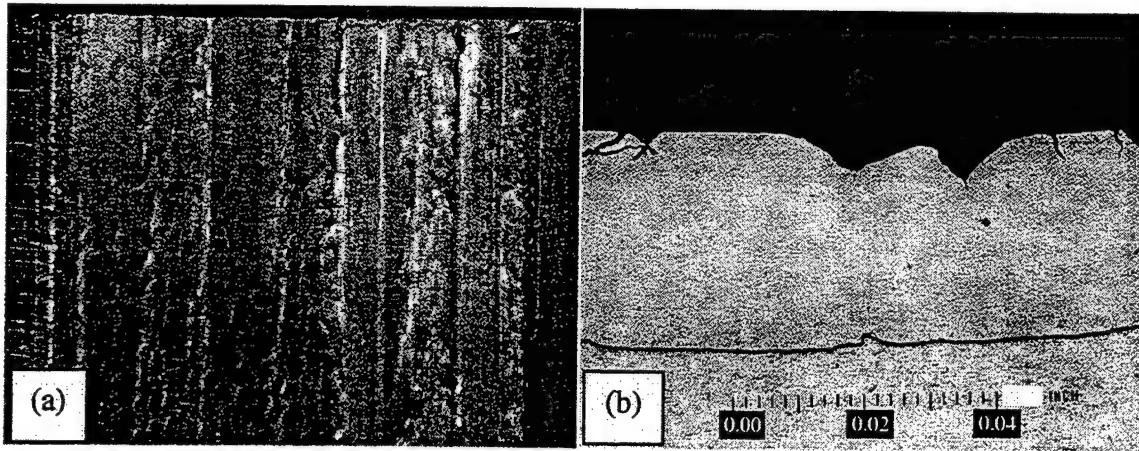
The most dominant feature of the Tube C specimens was severe erosion of the lands up to about 16 inches from RFT (Figures 7 and 8), including near complete obliteration nearest the origin-of-rifling (4- to 8-inch location). Also, seen in the liner of the 4- to 8-inch section were heavy heat-checking and stress patterns similar to those observed in Tube B.

Figure 7. (a) Heat-checking and land erosion at 4 to 8 inches from RFT, and (b) cross-section of Tube C at 50X.

The main area of concern in the erosion of the no-twist rifled Tube C is the obliteration and overall damage to the lands extending down bore to at least 16 inches from RFT. Considering that the gun bore consisted of a *no-twist* rifling alignment, the mechanical stresses on the liner were not as severe as would be the case in a true Bushmaster gun tube.

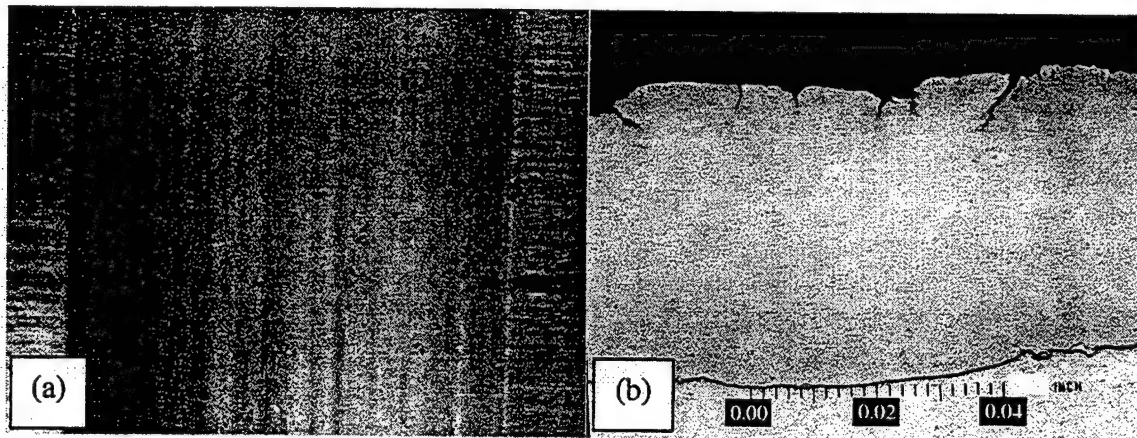
Figure 8. (a) Surface roughening and land erosion at 14 to 16 inches from RFT, and (b) cross-section of Tube C at 50X.

Besides the heavy wear and erosion seen in the main bore in the 14- to 16-inch location, there occurred a general roughening similar to that of Tube B. As with Tube B, this roughening seemed to occur due to cracking of the coating at the surface, followed by deformation and preferential erosion within the cracks (Figure 8b).

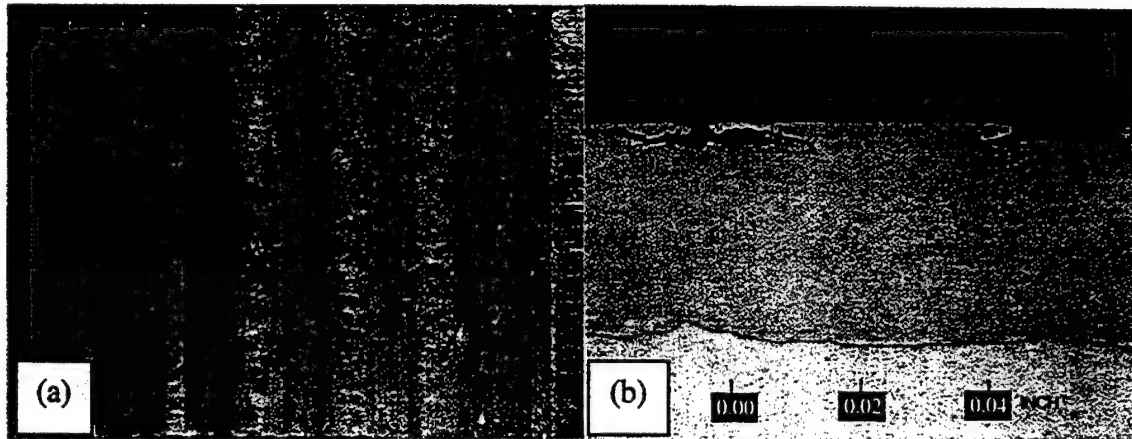
A general roughening of the surface in the 28- to 30-inch location was also observed (Figure 9a). The roughening observed here is due to both cracking and loss of the coating at what appears to be an interfacial phase formed from the dual explosive bonding process (Figure 9b), which will be discussed in a later section.

Figure 9. (a) Wear and surface roughening at 28 to 30 inches from RFT, and (b) longitudinal cross-section of Tube C at 50X.

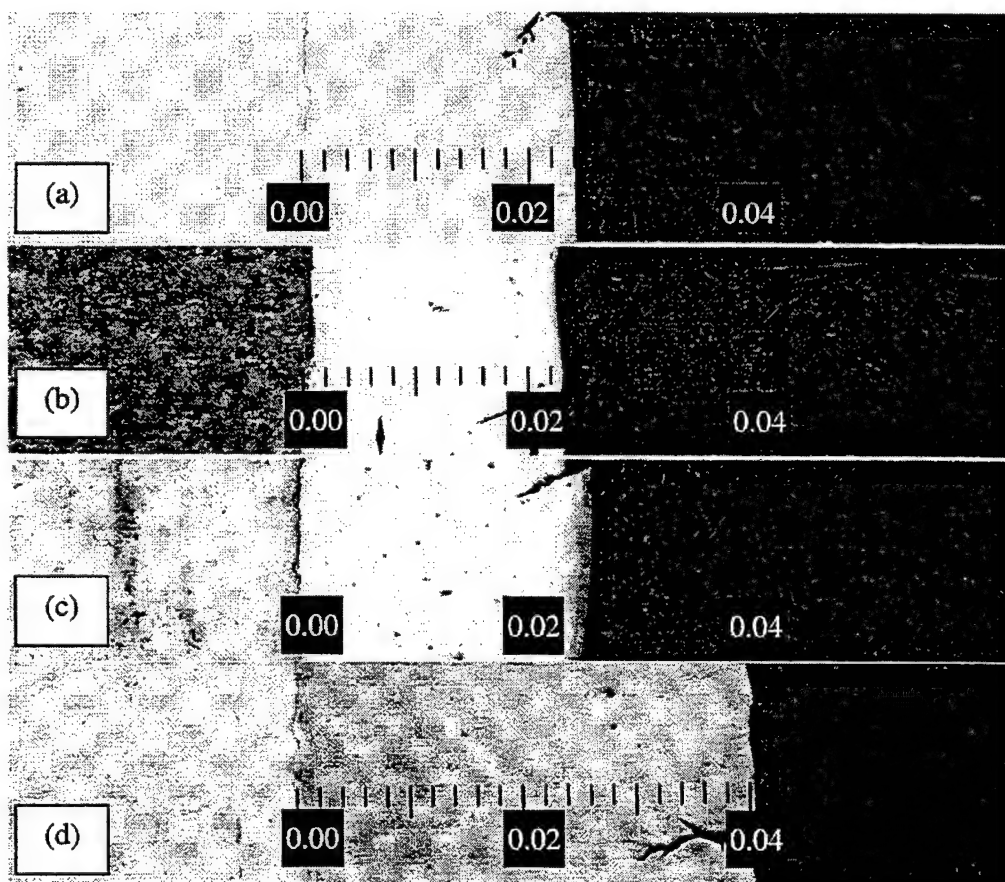
For Tube B, liner thickness measurements were made at 6.5, 10, 14, 20, and 40 inches from RFT in the fired smoothbore specimen. Assuming an initial liner thickness of $\sim 0.040\text{-inch}$, the final thickness measurements of the liner agree well with the bore gauging measurements taken during testing at Aberdeen Proving Ground (ref 1). Figure 11 illustrates several thickness measurements. See Table 1 for complete coating thickness measurements.

Figure 11. Coating thicknesses of Tube B at (a) 6.5, (b) 10, (c) 14, and (d) 20 inches from RFT.

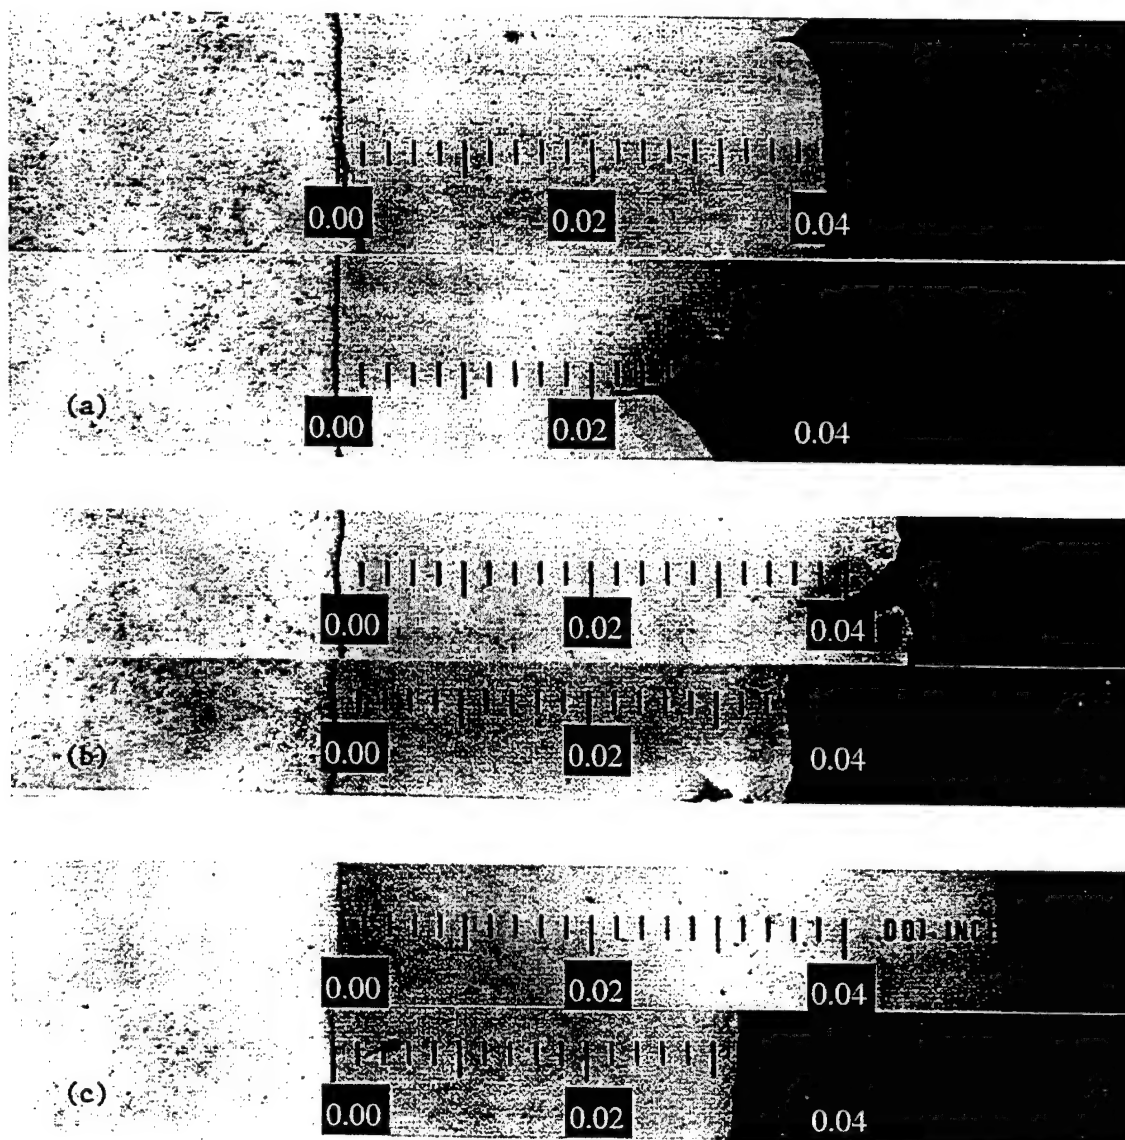
For Tube C, liner thickness measurements were made at 8, 14, 30 and 40 inches from RFT in the fired, no-twist, rifled specimen. At the 8-inch location, the lands were difficult to distinguish from the grooves in the stereomicroscope, as near complete obliteration of the lands had occurred in this location. The liner thickness down bore was much greater than the nominally reported 0.042- and 0.021-inch for land and groove, respectively; but if in fact the liner thickness was indeed 0.060-inch on the lands and 0.037-inch in the grooves, the erosion data compiled at ATC would better correlate to the thickness readings. Figure 12 illustrates several thickness measurements. See Table 1 for complete coating thickness measurements.

Figure 12. Coating thicknesses of Tube C at (a) 8, (b) 16, and (c) 30 inches from RFT.

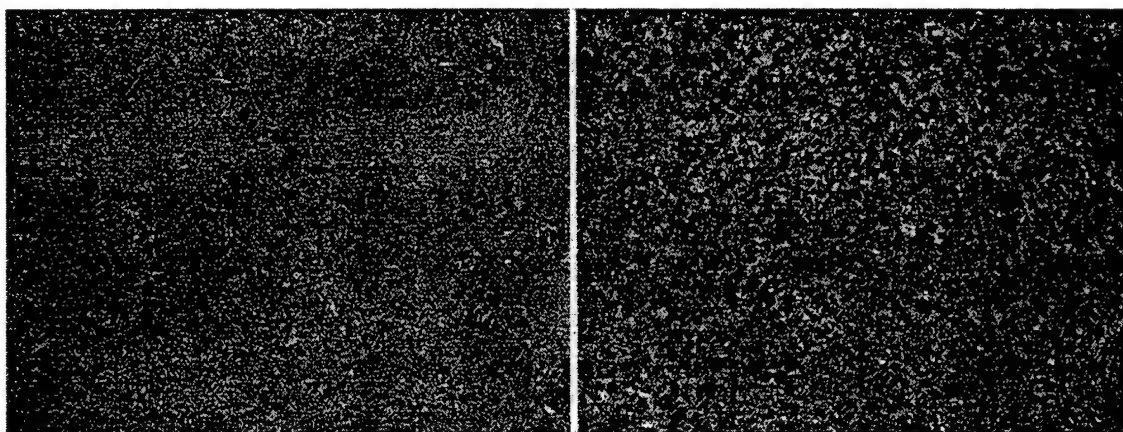
The liner of Tube B exhibited the same bulk features as Tube A. The liner was dense and defect-free and along much of the interface, a brittle and cracked intermetallic was present. The microhardness of the intermetallic in this tube was also $\sim\text{HK}_{50}$ 900. An image illustrating the comparative hardness values of the steel, intermetallic, and tantalum liner is given in Figure 15. Besides minor plastic deformation, the steel microstructure appeared relatively unaffected by the explosive bonding process. The one location examined in which the microstructure of the steel was noticeably altered occurred at the 8-inch location (Figure 16b). Although the microstructure is altered, there is no significant hardening or softening of the steel, so the ramifications of this insofar as fatigue life is concerned are unknown.

Figure 16. (a) Tempered martensitic structure of Tube B at 500X, and (b) altered interfacial region at 8-inch location at 500X.

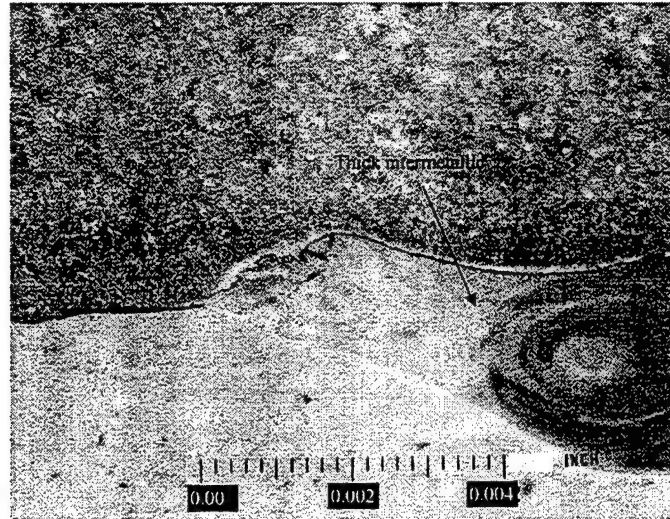
The microstructure of the bulk coating of Tube C was dense and defect-free. Again, an intermetallic was present along much of the interface of this specimen exhibiting similar properties as those in Tubes A and B. From metallographic examination, it appears the explosive bonding process was overly energetic at the 30-inch location. Here, a very thick intermetallic (~3 to 5 mils) was present as is illustrated in Figures 17 and 18. Along with this, a shallow heat-affected zone is present in the steel at the interface of the intermetallic.

Figure 18. Thick intermetallic and heat-affected zone of Tube C at 30 inches from RFT at 500X.

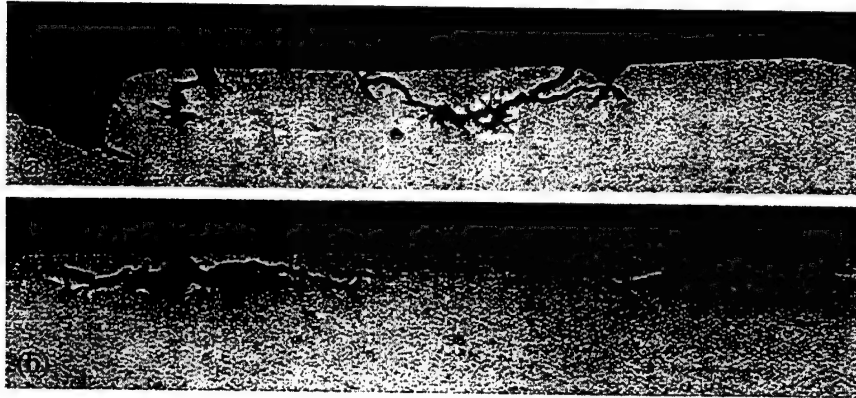
Figure 20. Interphase degradation of Tube C at (a) 8-inch location, and (b) 30-inch location.

The overall erosion characteristics and cracking of Tube C are similar to that of Tube B with the exception of failure of the liner at the interphase tantalum formed by the dual-explosive bonding process. The presence of this phase at an interface near the surface of the liner may lead to extensive premature liner spallation of the lands during firing.

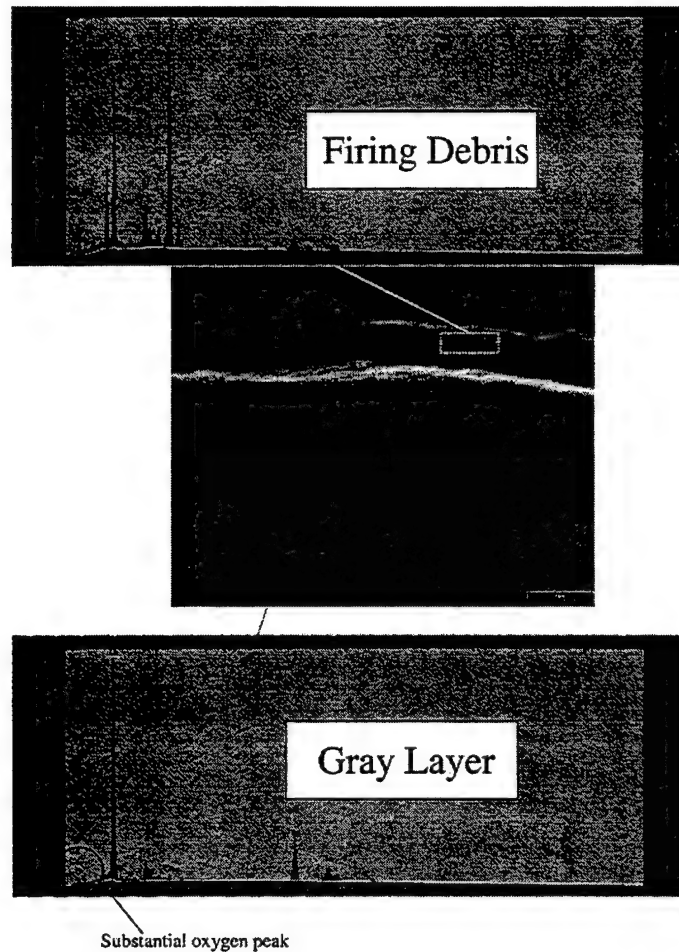
In addition, Figure 23 illustrates a gray layer observed on the surface. Based on EDS results, this layer appears to be a tantalum oxide (Figure 24). This is further supported by the WDS results described next.

Figure 24. Results of EDS on surface layer of the Tube C tantalum liner. The substantial oxygen peak observed indicates the presence of a surface oxide.

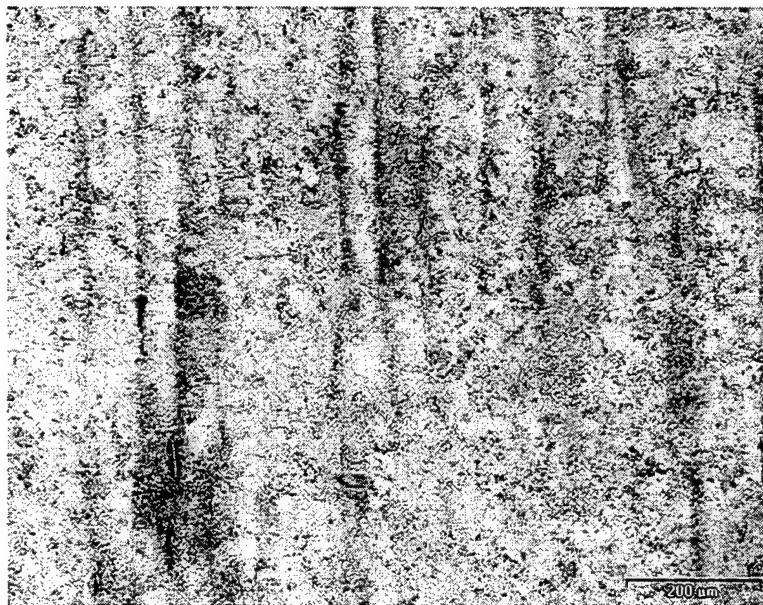
Etching revealed banding parallel to the tube axis throughout the steel substrate of Sample A, as shown in the cross-section of Figure 25. There are many occurrences of inclusions oriented along the bands. These features reflect the quality of material used for the manufacture of this gun tube.

Figure 25. Substrate steel of unfired explosively bonded tantalum-coated gun tube at magnification 200X. This cross-section is perpendicular to the bore and parallel to the tube axis.

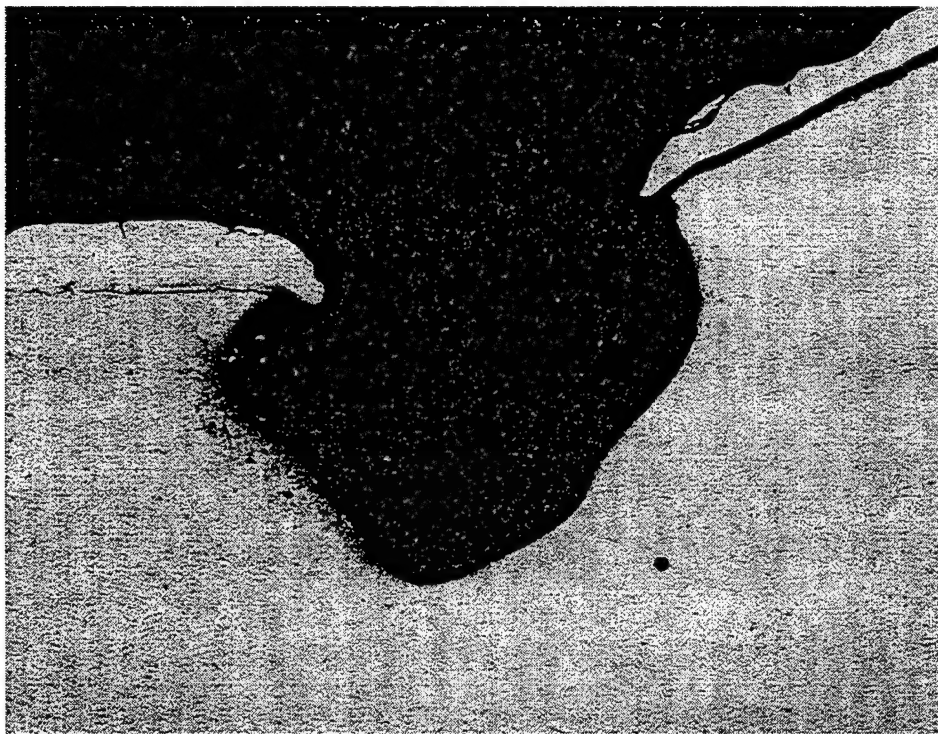
Figure 45. Severe erosion of underlying steel in Tube B at 8 inches from RFT at 15X.
